**Flood Control Project Maintenance
Levee Inspections**

Maintenance Issue Types Only, Levee Inspection Report By Mile - Fall 2018

Tehama County Flood Control and Water Conservation District

Waterway	Bank	Unit Miles	Inspection Start/End	Inspector
Unit No. 01 Deer Creek	Left	4.22	10/02/2018 10/02/2018	Bob Duffey

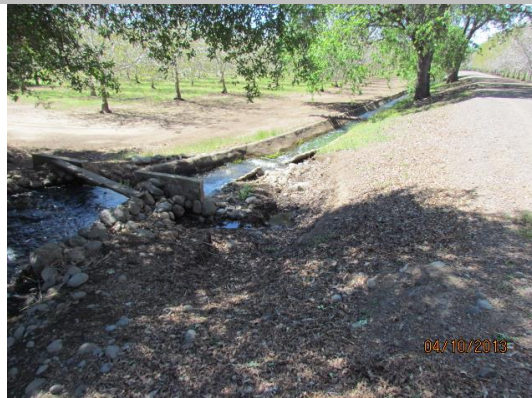
Photo 1 of 1 : FA_2018_NA0019_78_17_20180905_00005.jpg

LM Start	0.01	Rating **	M	Issue No.	17
LM End	0.01	Issue Type +	Ma	Location *	LS
Category	Earthen Levee			GPS Latitude/Longitude	
				Start	End
Item	Erosion / Bank Caving			39.973111 °	39.973111 °
				-121.980466 °	-121.980466 °
DWR ID	DWR_NA0019_01_s_2013_17				
Comment Code					
E1 : Note and monitor erosion site.					
Inspector Comment

View of the erosion along the landside slope.

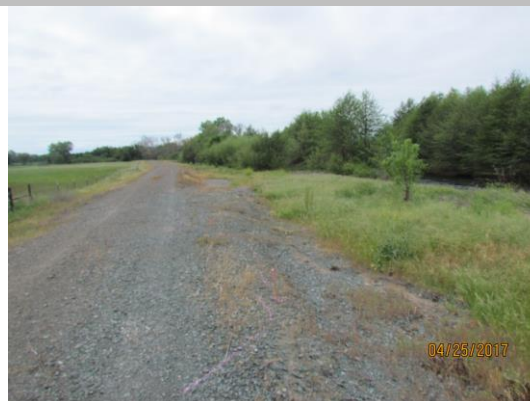
Photo 1 of 1 : FA_2018_NA0019_78_39_20180905_00014.jpg

LM Start	2.53	Rating **	M	Issue No.	39
LM End	2.53	Issue Type +	Ma	Location *	WS
Category	Earthen Levee			GPS Latitude/Longitude	
				Start	End
Item	Erosion / Bank Caving			39.966675 °	39.966675 °
				-122.024988 °	-122.024988 °
DWR ID	DWR_NA0019_01_s_2017_39				
Comment Code					
E2 : Schedule repair of erosion site prior to the next inspection.					
Inspector Comment					
Repair the erosion along the water side slope.

View of erosion along the waterside slope.

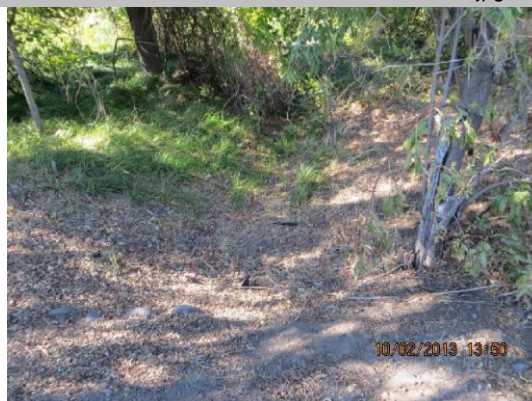
Photo 1 of 2 : UCIP_FA_2018_22824_38946.jpg

LM Start	2.86	Rating **	M	Issue No.	284
LM End	2.86	Issue Type +	Ma	Location *	
Category	Supplemental			GPS Latitude/Longitude	
				Start	End
Item	DWR UCIP LMA Responsibility			39.963938 °	39.963938 °
				-122.030128 °	-122.030128 °
DWR ID	20767				
Comment Code					
Inspector Comment					
FS_ID:22824					
DS_ID:20767					
EP_NO: N/A					
Repair Type: Non-Urgent					
Crossing Status: Found					
UCIP Comments: Pipe blocked by soil.					
FIELD_STRUCT_DESC: 24-inch corrugated metal drainage pipe through the levee, 6 feet below the crown. Flap gate on the waterside (WS) end. [Additional Reference(s): DWR Levee Log, 1992. USACE Sacramento O&M Manual 509, March 1957, (Assumed Station 137+50) Drawing No. 50-4-2394].					
FS Date: 10/2/2013

Flapgate blocked by soil and debris.

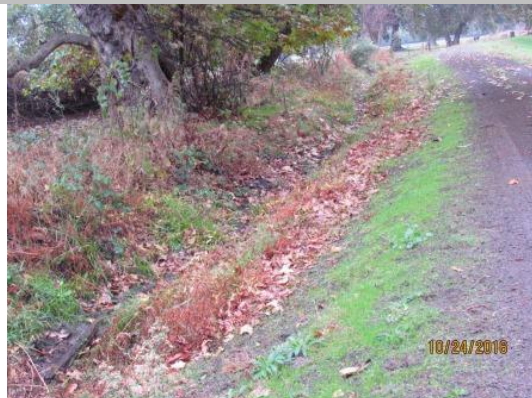
Photo 1 of 1 : FA_2018_NA0019_78_35_20180905_00011.jpg

LM Start	3.58	Rating **	M	Issue No.	35
LM End	3.58	Issue Type +	Ma	Location *	LS
Category	Earthen Levee			GPS Latitude/Longitude	
				Start	End
Item	Vegetation			39.946051 °	39.946051 °
				-122.053985 °	-122.053985 °
DWR ID	DWR_NA0019_01_f_2016_35				
Comment Code					
V2 : Remove the wild growth other than native grasses from the levee slopes.					
Inspector Comment

View of the vegetation along the landside slope and toe.

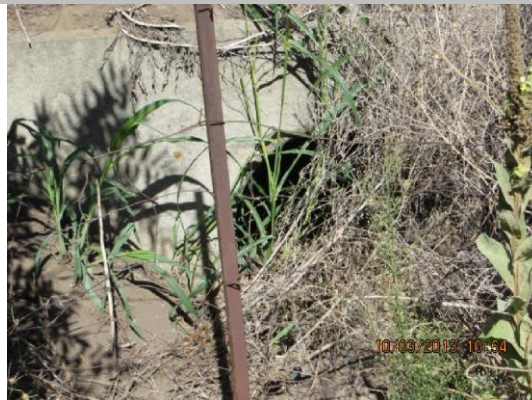
Photo 1 of 3 : UCIP_FA_2018_21741_36937.jpg

FS_ID:21741
DS_ID:20760
EP_NO: N/A
Repair Type: No Action Needed
Crossing Status: Found
UCIP Comments:
FIELD_STRUCT_DESC: 24-inch corrugated metal drainage pipe through the levee, 5 feet below the crown. Flap gate on the waterside (WS) end. Headwalls on both sides of levee. [Additional Reference(s): DWR Levee Log, 1992. USACE Sacramento O&M Manual 509, March 1957, (Assumed Station 5+00) Drawing No. 50-4-2394].
FS Date: 10/3/2013

Pipe and concrete headwall on LS toe.

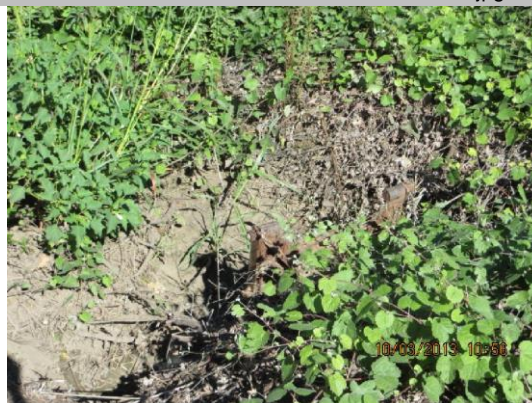
Photo 2 of 3 : UCIP_FA_2018_21741_36936.jpg

Flapgate on WS toe.

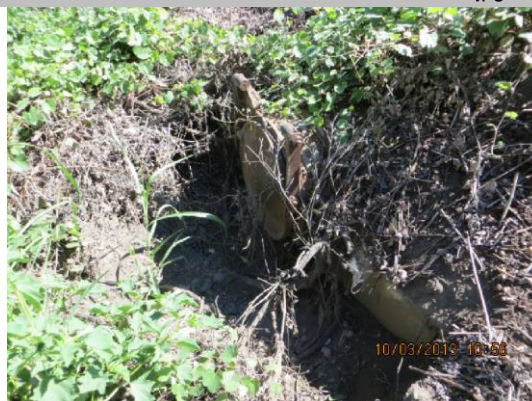
Photo 3 of 3 : UCIP_FA_2018_21741_36935.jpg

Flapgate and concrete headwall on WS toe.

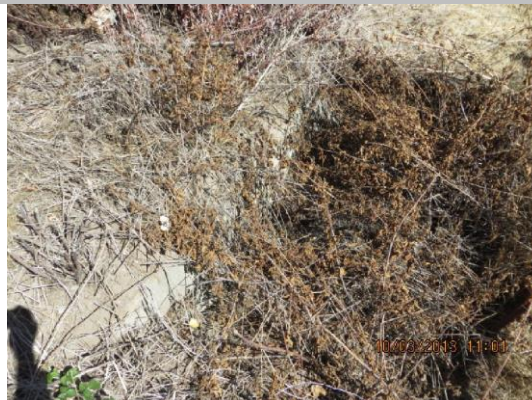
Photo 2 of 3 : UCIP_FA_2018_53395_36941.jpg

Comment Code						
Inspector Comment						
FS_ID:53395						
DS_ID:20762						
EP_NO: N/A						
Repair Type: Urgent						
Crossing Status: Found						
UCIP Comments: 10/15/2018 Missing flap gate at WS end of the pipe.						
Pipe is partially blocked with silt. Updated coordinates and CLM.						
(O.Yakimov - DWR)12/05/2016 unable to complete inspection --						
unable to locate. (O. Magana - DWR UCIP)10/03/2013 Gate missing						
from WS toe. (W. Wylie - DWR UCIP)						
FIELD_STRUCT_DESC: 24-inch corrugated metal drainage pipe						
through the levee, 5.5 feet below the crown. Flap gate located on the						
waterside (WS) end. Concrete headwall located on the landside (LS)						
toe. [Additional Reference(s): DWR Levee Log, 1992. USACE						
Sacramento O&M Manual Unit 509, March 1957, As-built drawing no.						
50-4-2394 (Station 0+65)].						
FS Date: 10/15/2018 3:37:24 PM

Concrete headwall at inlet on LS toe.

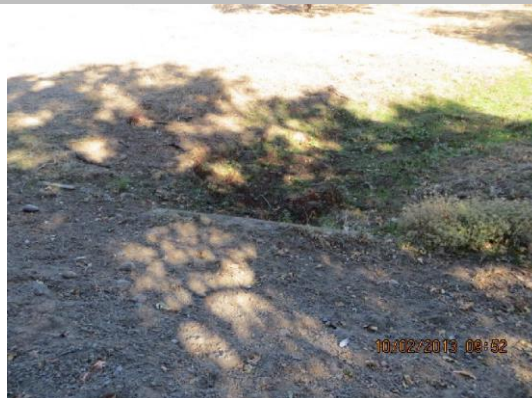
Photo 1 of 3 : UCIP_FA_2018_51442_36902.jpg

Comment Code					
Inspector Comment					
FS_ID:51442 DS_ID:20771 EP_NO: N/A Repair Type: Non-Urgent Crossing Status: Found UCIP Comments: 12/05/2016 Crossing has been downgraded from Urgent to Non-Urgent some debris blocking proper function of flapgate on WS. Recommend clearing debris from WS for flapgate to function properly. (O. Magana - DWR UCIP)10/01/2013 Debris blocking proper function of flapgate on WS toe. (W. Wylie - DWR UCIP) FIELD_STRUCT_DESC: 24-inch steel drainage pipe through the levee, 8.3 feet below the crown. Flap gate located on the waterside (WS) end. Concrete headwall located on the landside (LS). [Additional Reference(s): DWR Levee Log, 1992. USACE Sacramento O&M Manual Unit 509, March 1957, Unit 510, April 1963, Unit 511, May 1973, Unit 512, March 1964, Unit 513, December 1970, As-builts drawing 50-4-2394 (Station 155+40)]. FS Date: 12/5/2016

Concrete headwall at LS toe.

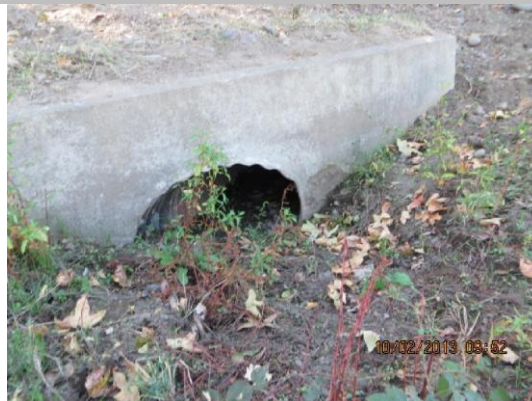
Photo 2 of 3 : UCIP_FA_2018_51442_36901.jpg

Concrete headwall at LS toe.

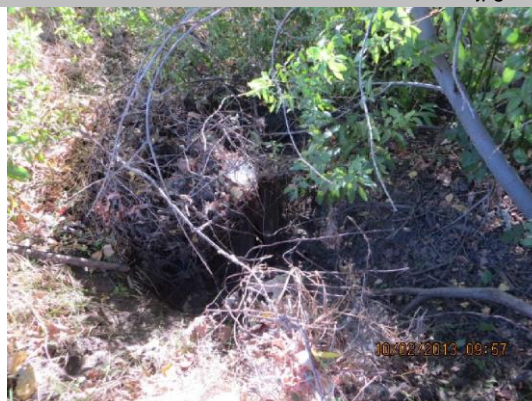
Photo 3 of 3 : UCIP_FA_2018_51442_36900.jpg

Comment Code						
Inspector Comment						
FS_ID:51442 DS_ID:20771 EP_NO: N/A Repair Type: Non-Urgent Crossing Status: Found UCIP Comments: 12/05/2016 Crossing has been downgraded from Urgent to Non-Urgent some debris blocking proper function of flapgate on WS. Recommend clearing debris from WS for flapgate to function properly. (O. Magana - DWR UCIP)10/01/2013 Debris blocking proper function of flapgate on WS toe. (W. Wylie - DWR UCIP) FIELD_STRUCT_DESC: 24-inch steel drainage pipe through the levee, 8.3 feet below the crown. Flap gate located on the waterside (WS) end. Concrete headwall located on the landside (LS). [Additional Reference(s): DWR Levee Log, 1992. USACE Sacramento O&M Manual Unit 509, March 1957, Unit 510, April 1963, Unit 511, May 1973, Unit 512, March 1964, Unit 513, December 1970, As-builts drawing 50-4-2394 (Station 155+40)]. FS Date: 12/5/2016

Outlet on WS toe.

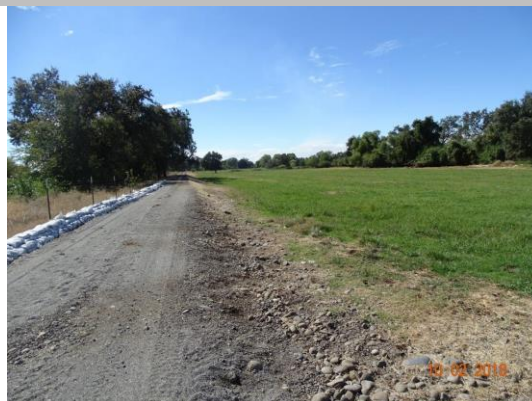
Photo 1 of 1 : FA_2018_NA0019_79_19_20181008_00016.jpg

LM Start	0.79	Rating **	A	Issue No.	19
LM End	1.31	Issue Type +	Ma	Location *	LS
Category	Earthen Levee			GPS Latitude/Longitude	
				Start	End
Item	Vegetation			39.968679 °	39.964525 °
				-122.022938 °	-122.031142 °
DWR ID	DWR_NA0019_02_f_2017_19				
Comment Code					
V2 : Remove the wild growth other than native grasses from the levee slopes.					
Inspector Comment					
The vegetation was removed from the landside slopes.

View of no vegetation along the landside slope.

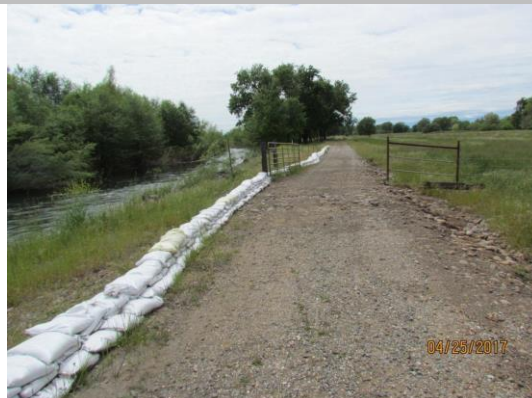
Photo 1 of 1 : FA_2018_NA0019_79_12_20180905_00005.jpg

LM Start	0.81	Rating **	M	Issue No.	12
LM End	0.85	Issue Type +	Ma	Location *	CR
Category	Earthen Levee			GPS Latitude/Longitude	
				Start	End
Item	Erosion / Bank Caving			39.968530 °	39.968248 °
				-122.023305 °	-122.023900 °
DWR ID	DWR_NA0019_02_s_2017_12				
Comment Code					
E2 : Schedule repair of erosion site prior to the next inspection.					
Inspector Comment					
Repair the crown roadway.

View of the erosion on the crown roadway.

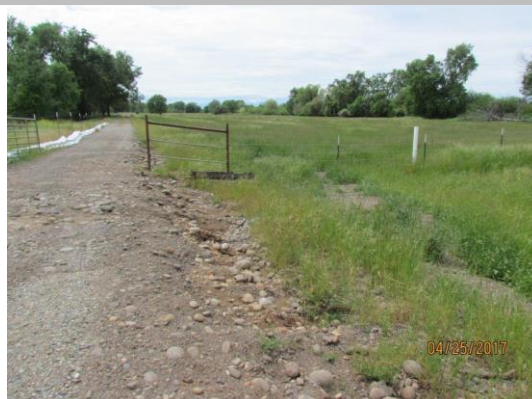
Photo 1 of 1 : FA_2018_NA0019_79_17_20180905_00008.jpg

LM Start	0.81	Rating **	M	Issue No.	17
LM End	0.85	Issue Type +	Ma	Location *	LS
Category	Earthen Levee			GPS Latitude/Longitude	
				Start	End
Item	Erosion / Bank Caving			39.968530 °	39.968248 °
				-122.023305 °	-122.023900 °
DWR ID	DWR_NA0019_02_s_2017_17				
Comment Code					
E2 : Schedule repair of erosion site prior to the next inspection.					
Inspector Comment					
Repair the erosion along the landside slope.

View of the erosion along the landside slope.

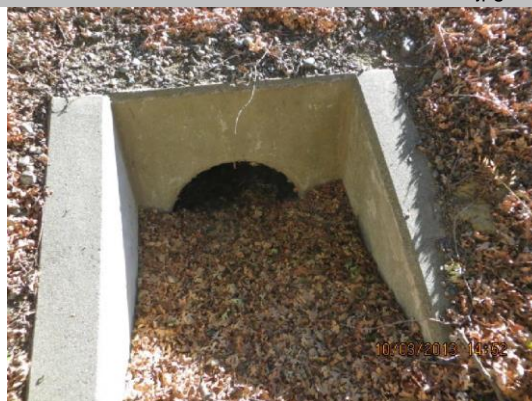
Photo 2 of 3 : UCIP_FA_2018_22826_38960.jpg

Concrete U-shaped headwall on LS toe.

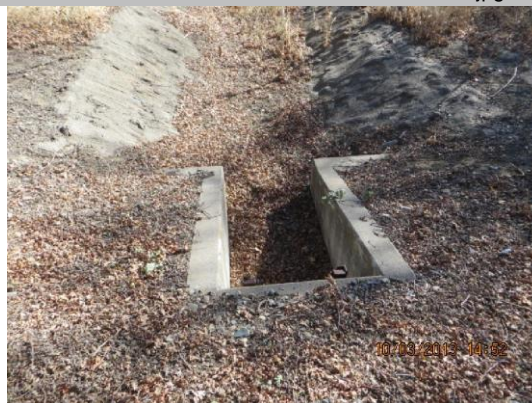
Photo 3 of 3 : UCIP_FA_2018_22826_38963.jpg

Concrete U-shaped headwall with concrete swale on WS toe.

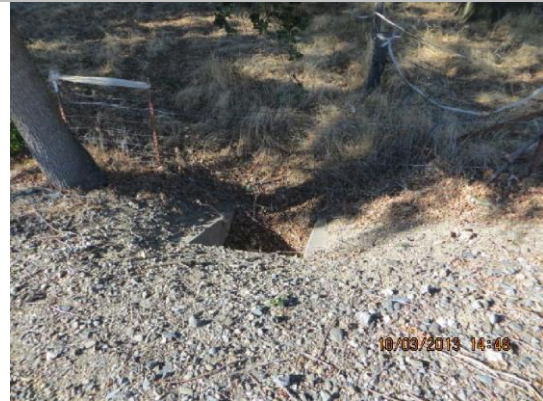
Photo 1 of 3 : UCIP_FA_2018_21793_37069.jpg

Concrete U-shaped headwall on LS toe.

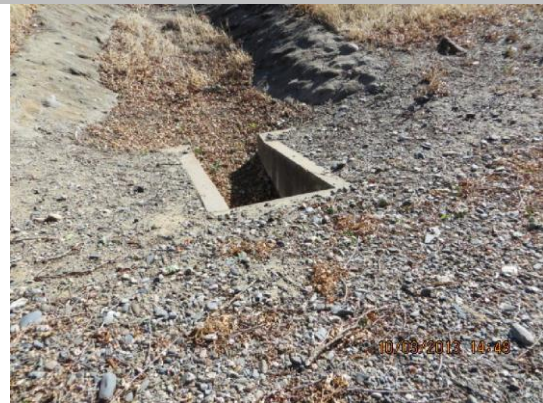
Photo 2 of 3 : UCIP_FA_2018_21793_37068.jpg

Concrete U-shaped headwall on WS toe.

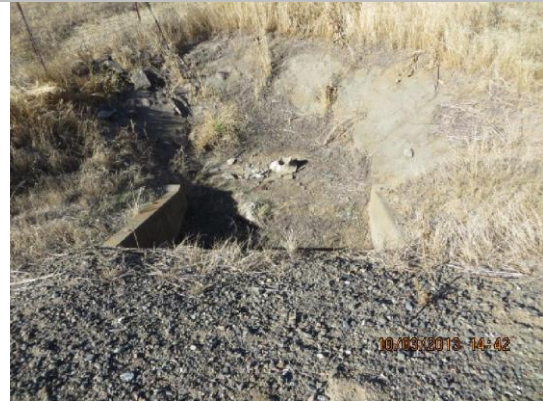
Photo 1 of 3 : UCIP_FA_2018_51443_37061.jpg

Concrete U-shaped headwall on LS toe.

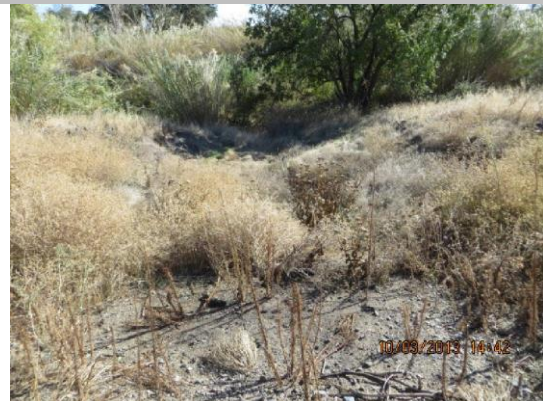
Photo 2 of 3 : UCIP_FA_2018_51443_37060.jpg

Concrete U-shaped headwall on WS toe.

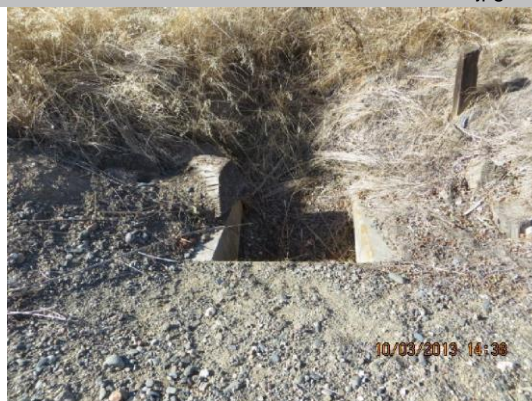
Photo 1 of 3 : UCIP_FA_2018_21790_37057.jpg

Concrete U-shaped headwall on LS toe.

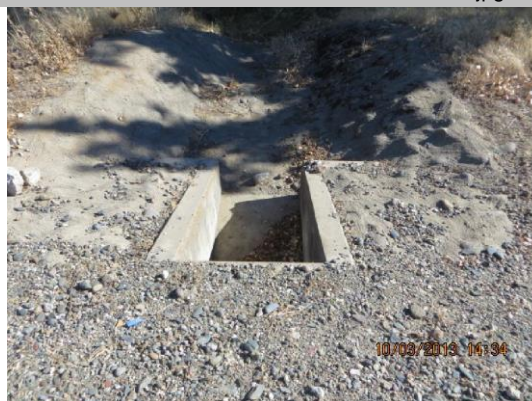
Photo 2 of 3 : UCIP_FA_2018_22827_38969.jpg

Concrete U-shaped headwall on WS toe.

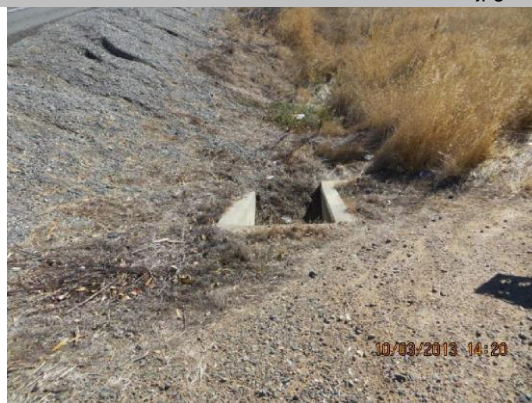
Photo 1 of 3 : UCIP_FA_2018_21788_37050.jpg

Concrete U-shaped headwall on WS toe.

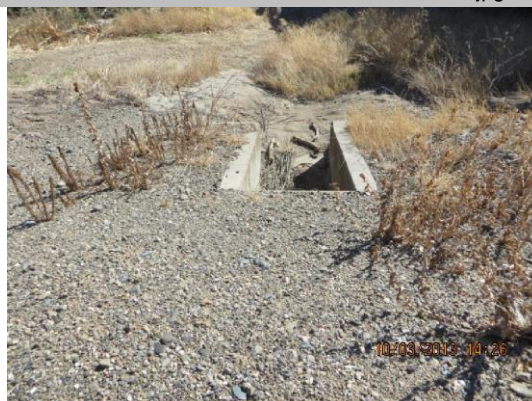
Photo 1 of 2 : UCIP_FA_2018_21786_37048.jpg

Concrete U-shaped headwall and flapgate on WS slope.

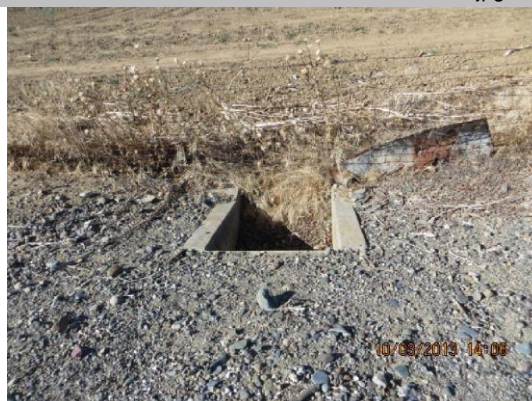
Photo 1 of 3 : UCIP_FA_2018_21776_37029.jpg

Concrete U-shaped headwall on LS toe.

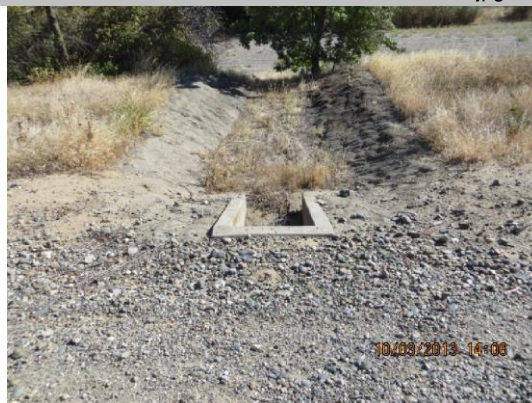
Photo 2 of 3 : UCIP_FA_2018_21776_37028.jpg

Concrete U-shaped headwall on WS toe.

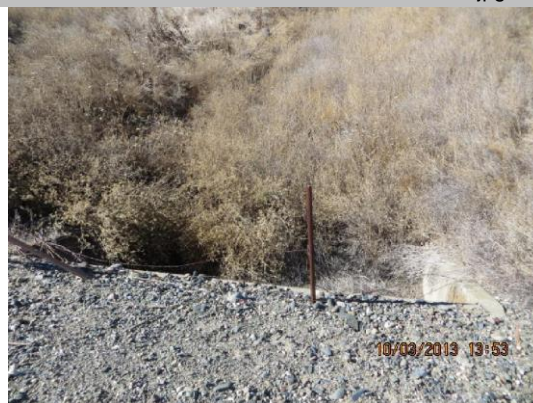
Photo 1 of 3 : UCIP_FA_2018_21769_37004.jpg

Concrete inlet on LS toe.

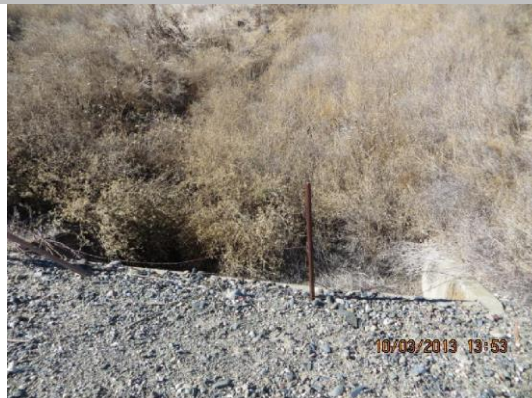
Photo 1 of 3 : UCIP_FA_2018_21768_37000.jpg

Concrete headwall on LS toe.

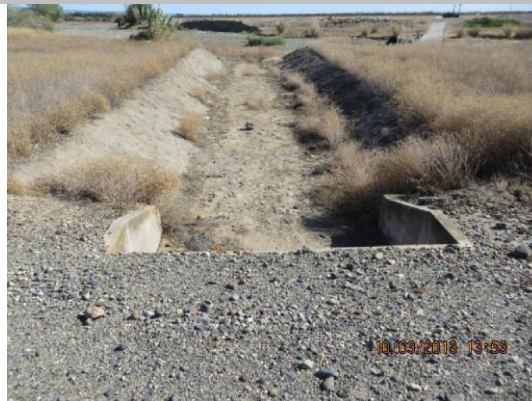
Photo 2 of 3 : UCIP_FA_2018_21768_36999.jpg

Concrete headwall on WS toe.

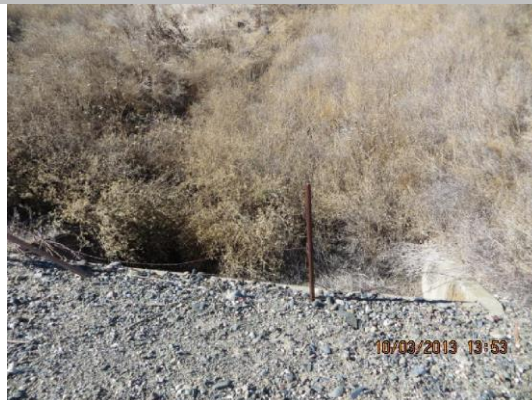
Photo 1 of 3 : UCIP_FA_2018_21767_36996.jpg

Concrete headwall on LS slope.

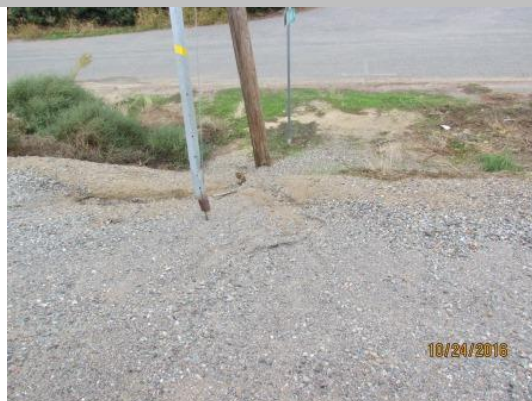
Photo 1 of 1 : FA_2018_NA0019_81_32_20180905_00019.jpg

LM Start	2.58	Rating **	M	Issue No.	32
LM End	2.58	Issue Type +	Ma	Location *	LS
Category	Earthen Levee			GPS Latitude/Longitude	
				Start	End
Item	Slope Stability			40.053767°	40.053767°
				-122.144719°	-122.144719°
DWR ID	DWR_NA0019_04_f_2016_32				
Comment Code					
S2 : Repair the levee slope damaged by foot traffic and prevent access where possible.					
Inspector Comment

View of the slope instability caused by vehicles along the landside slope.

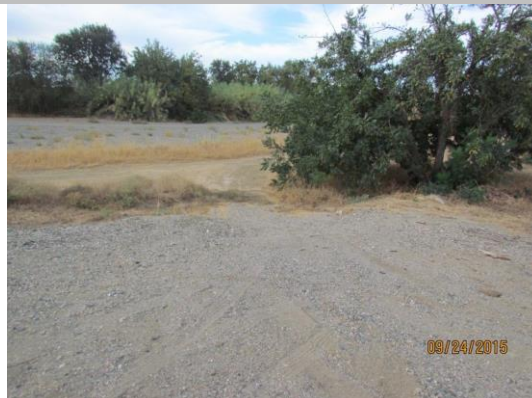
Photo 1 of 1 : FA_2018_NA0019_81_10_20180905_00006.jpg

LM Start	3.01	Rating **	M	Issue No.	10
LM End	3.01	Issue Type +	Ma	Location *	WS
Category	Earthen Levee			GPS Latitude/Longitude	
				Start	End
Item	Slope Stability			40.056388 °	40.056388 °
				-122.139168 °	-122.139168 °
DWR ID	DWR_NA0019_04_s_2012_10				
Comment Code					
S3 : Repair the levee slope damaged by vehicle traffic and prevent access where possible.					
Inspector Comment

View of the slope instability caused by vehicles along the landside slope.

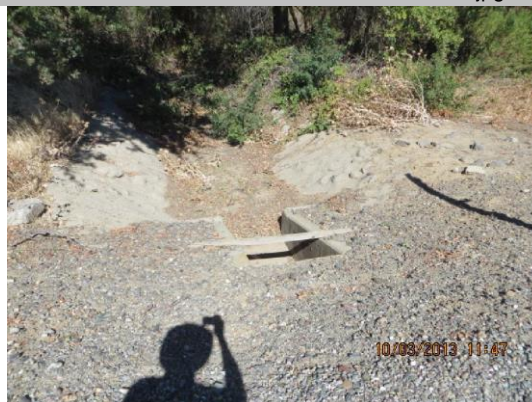
Photo 1 of 3 : UCIP_FA_2018_41124_36953.jpg

Concrete headwall on WS toe.

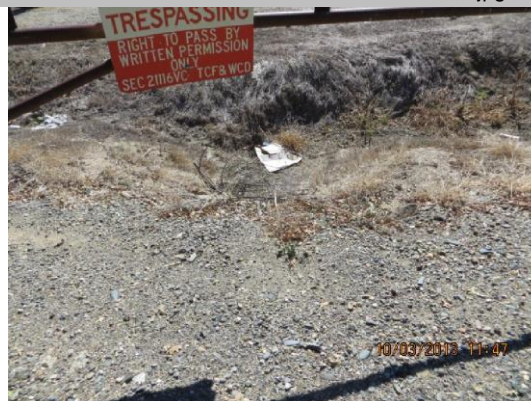
Photo 2 of 3 : UCIP_FA_2018_41124_36952.jpg

Inlet at LS toe.

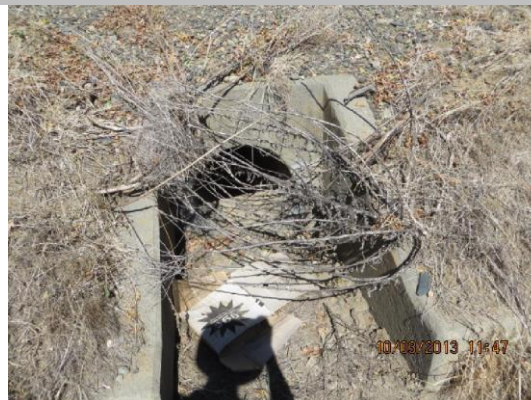
Photo 3 of 3 : UCIP_FA_2018_41124_36951.jpg

Concrete headwall at LS toe.

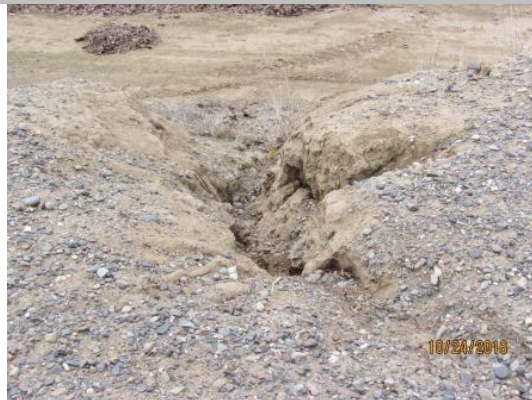
Photo 1 of 1 : FA_2018_NA0019_82_18_20180905_00007.jpg

LM Start	3.76	Rating **	U	Issue No.	18
LM End	3.76	Issue Type +	Ma	Location *	LS
Category	Earthen Levee			GPS Latitude/Longitude	
				Start	End
Item	Erosion / Bank Caving			40.054829 °	40.054829 °
				-122.129329 °	-122.129329 °
DWR ID	DWR_NA0019_05_f_2016_18				
Comment Code					
E2 : Schedule repair of erosion site prior to the next inspection.					
Inspector Comment

View of the erosion along the landside slope.
